Predicting Contamination Flashover of Insulators: Successes and Shortcomings of Tests and Simulations

Ravi S. Gorur and S. Venkataraman (Ph. D Student), Arizona State University

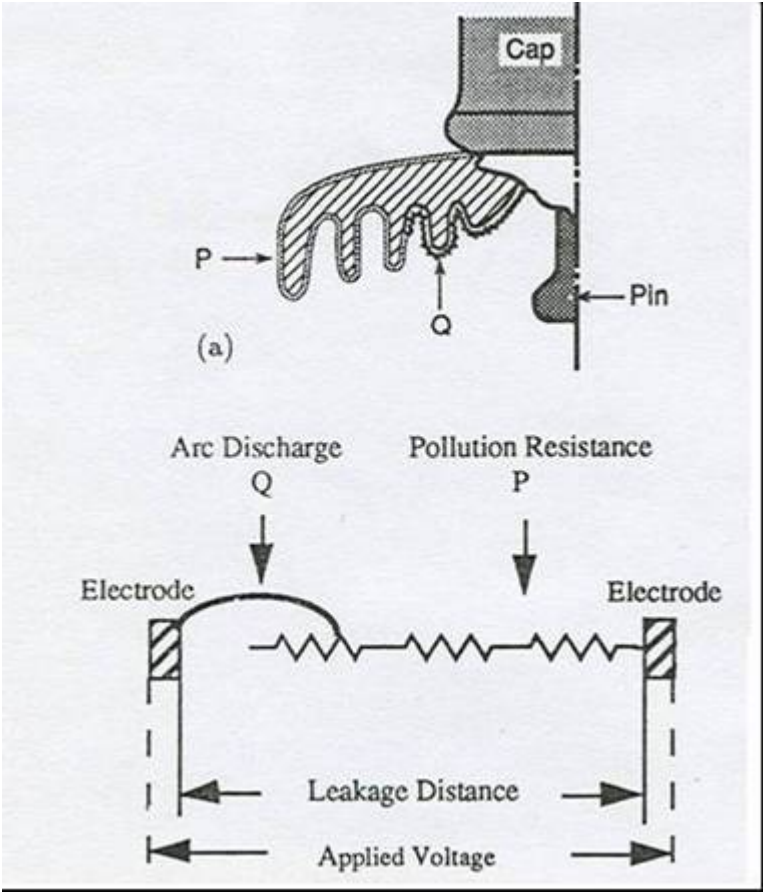
Fig. 1: Schematic of a contaminated insulator with dry band discharge initiated.

The earliest scientific explanations for contamination flashover was the theory proposed by Obenaus in the 1930s [1]. He explained flashover in very simple terms with the schematic shown in Fig. 1. A partial arc generated by dry band activity is in series with the contaminated section of the insulator and this is represented as a series resistance. Various factors are responsible for the partial arc to elongate and bridge enough of the insulator (roughly 50%) which will then provide the necessary impetus to result in a flashover. An increase in contamination severity on the insulator is one factor that contributes to flashover.

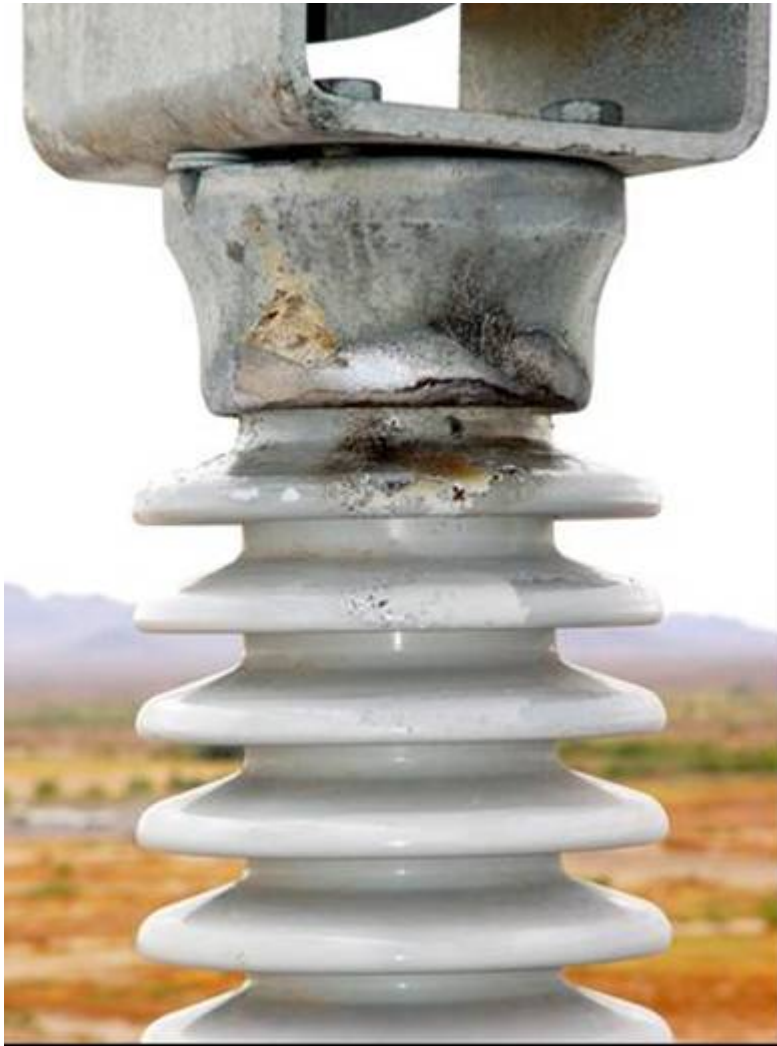
Fig. 2: Flashed 230 kV porcelain station post. Contamination was suspected as the root cause, but as is clear from the photograph, the insulator looks fairly clean.

Figs. 2-4 show pictures of insulators that had “allegedly” flashed over due to contamination. It is quite obvious that except for the top surface the rest of the insulator is actually clean. Does this mean that all the contamination was removed by the power arc? This is very unlikely as the power arc is in air and is in contact with the insulator surface closest to the high voltage and ground electrode. The only other explanation is that flashover happened in a manner that is not adequately explained by existing theories and testing.

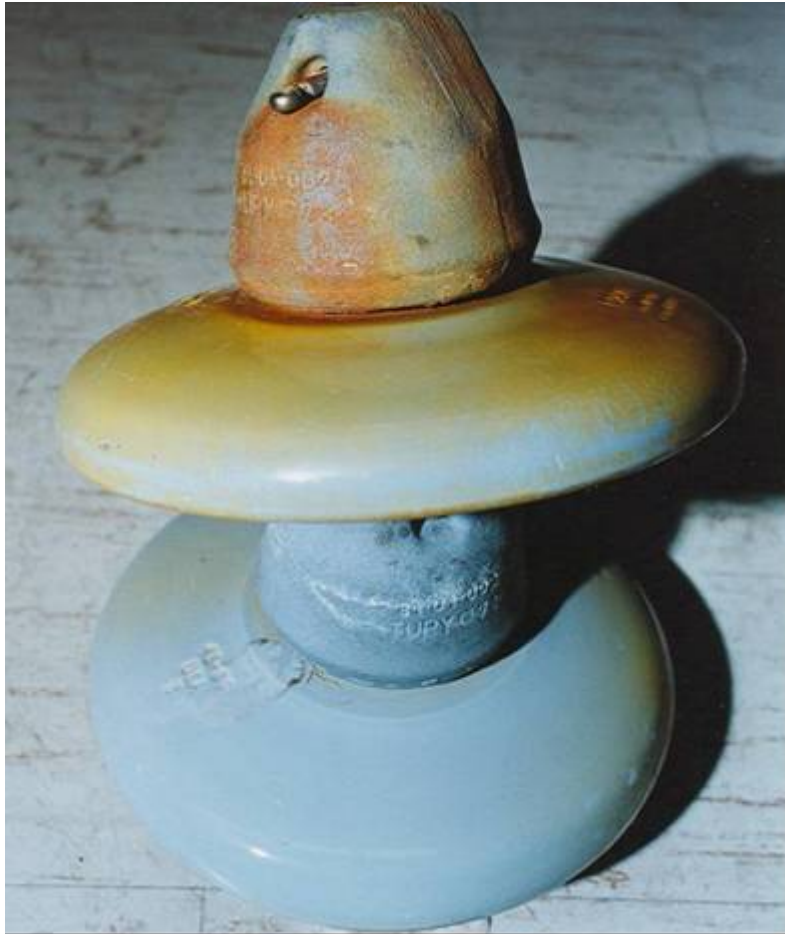
Fig. 3: Flashed porcelain cap and pin suspension insulators from a mining location in the USA. Contamination was suspected as the root-cause, but except for hardware staining on the top bell, the rest of the bells look fairly clean (ESDD measured $<0.05 \text{ mg/cm}^2$).

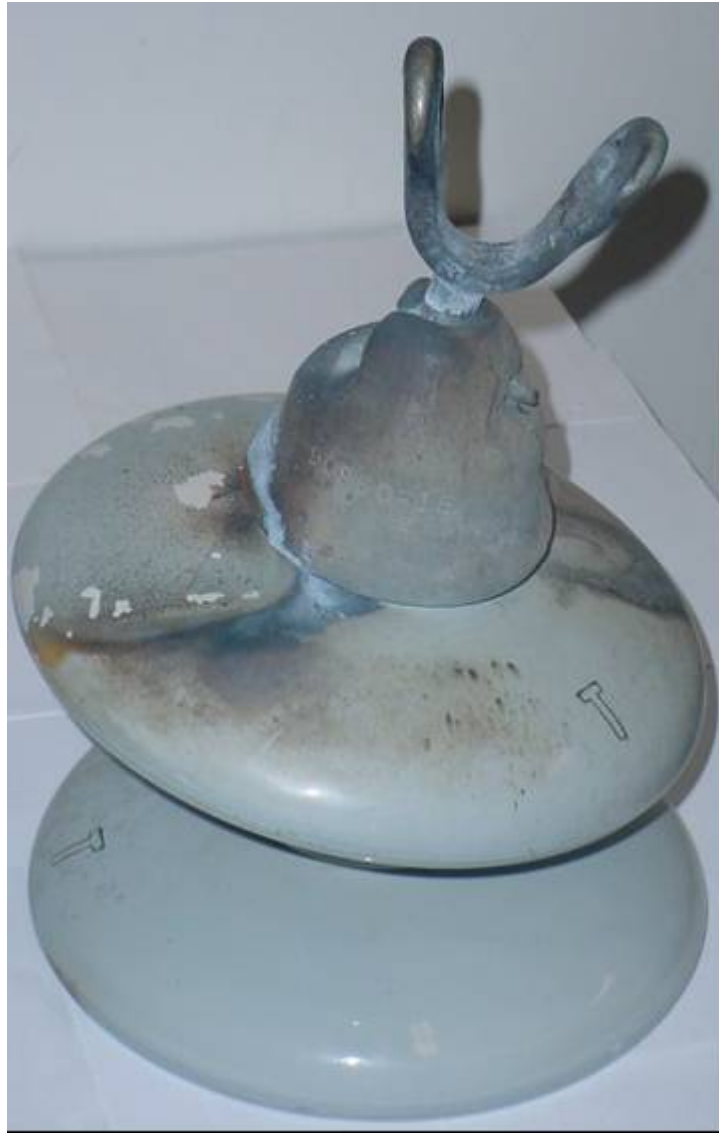
Fig. 4: Flashed porcelain cap and pin suspension insulators from an urban location in the USA. Contamination was suspected as the root-cause, but except for glaze damage on the top bell, the rest of the bells look fairly clean (ESDD measured $<0.03 \text{ mg/cm}^2$).
